Montgomery County's Special Protection Areas: Evaluating Best Management Practice Effectiveness at Protecting High Quality Waters

Montgomery County
Department of Environmental Protection

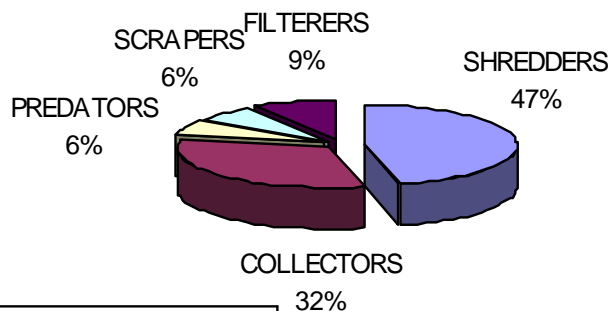
Functional Feeding Groups; Clarksburg Pre-Construction (1996-2000)

Dominant Taxa

Amphinemura sp. (Shredder) = 43 %
Chironomidae (Collector) = 20 %
 N=35
 Total # of Stations=9

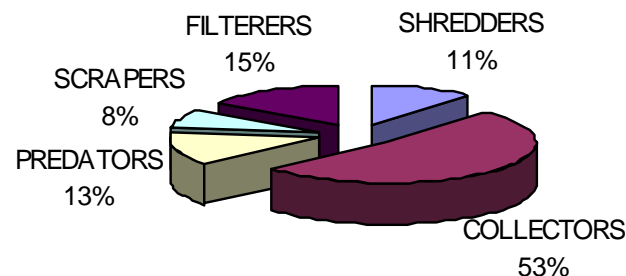
Functional Feeding Groups; Clarksburg Through Construction (2003-2007)

Dominant Taxa

Chironomidae (Collector) = 52 %
Amphinemura sp. (Shredder) = 8 %
 N=37
 Total # of Stations=9

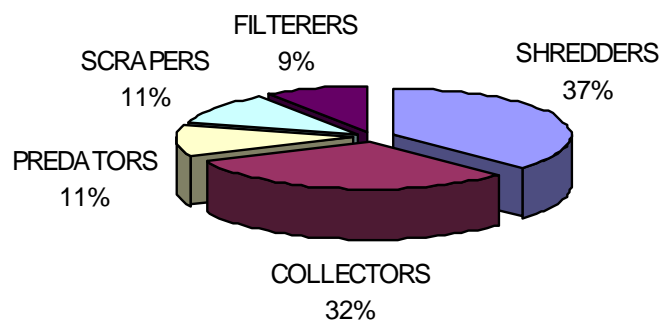
Functional Feeding Groups; Clarksburg Control (1996-2000)

Dominant Taxa

Amphinemura sp. (Shredder) = 33 %
Chironomidae (Collector) = 21 %
 N=25
 Total # of Stations=8

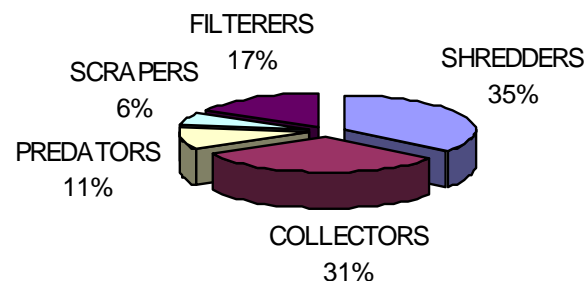
Functional Feeding Groups; Clarksburg Control (2003-2007)

Dominant Taxa

Chironomidae (Collector) = 33 %
Amphinemura sp. (Shredder) = 32 %
 N=27
 Total # of Stations=8
